NOTICE TO MARINERS Lowestoft Approaches – East Cardinal/Twin Buoy out of Position

Divisional Harbour Master East Anglia

14 May 2024

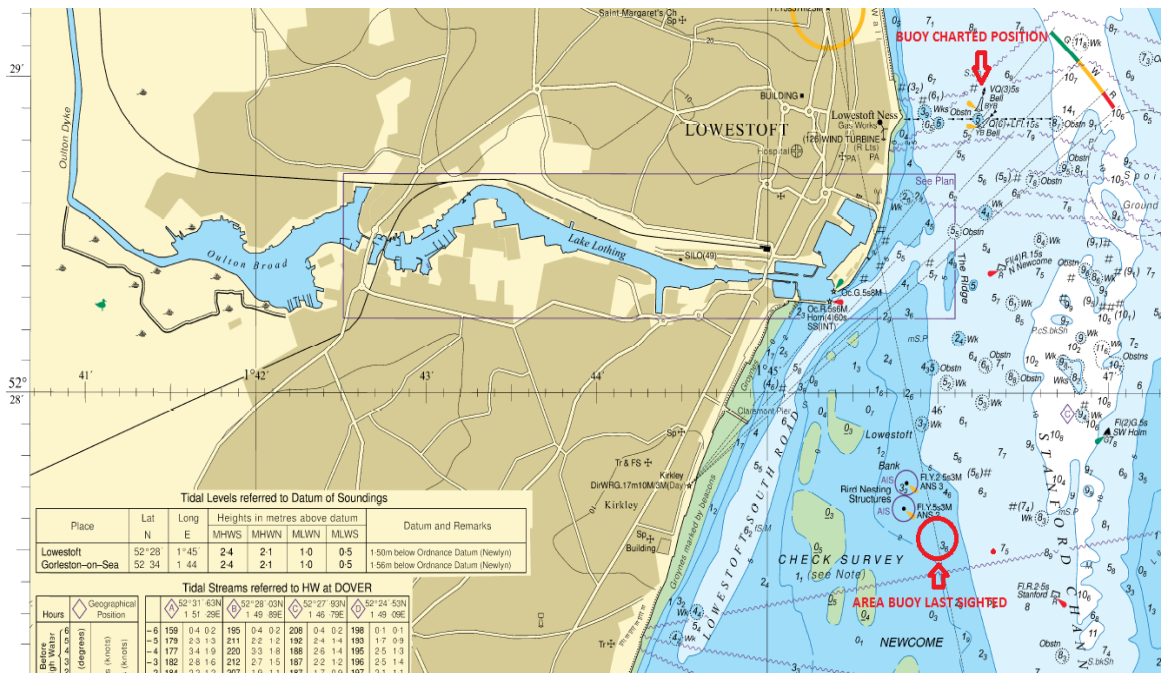
East Cardinal Buoy Out of Position

Mariners and Port Users are advised that the East Cardinal Twin (or Sewer) Buoy, normal position 52° 28.89'N, 001° 46.24'E, is currently out of position. The buoy appears to have broken from its moorings and drifted to the South. Last reported position, at 1430hrs 14/05/24, was at 52° 27.57'N, 01° 45.99'E (approximate location shown below).

The buoy is believed to have some of its moorings attached, but is likely to drift from its current position, subject to influence from tide or weather. It is assumed that the buoy light remains operational.

Mariners are requested to navigate with caution in Lowestoft Approaches. Updates of the buoy position, particularly if different to the above, should be passed to Lowestoft Port Control whenever possible.

Work is in hand to arrange for the buoy to be recovered and reinstated in position ASAP.
