NOTICE TO MARINERS <u>Lowestoft Approaches – South Cardinal Twin (Sewer)</u> <u>Buoy Out of Position - Update</u>

03 September 2024

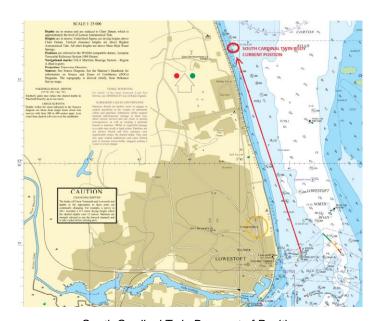
Mariners and Port Users are advised that the South Cardinal Twin (or Sewer) Buoy, normal position 52° 28.84'N, 01° 46.25'E, is currently out of position. The buoy appears to have broken from its moorings and drifted to the North. Last reported position, at 14:00hrs 03/09/24, was at 52° 31.40'N, 01° 44.80'E (approximate location shown below).

The buoy is believed to have some of its moorings attached. It may drift from its current position, subject to influence from tide or weather, but updates suggest that the buoy moorings may now be holding in this latest position. The buoy light is reported to be operational.

South Cardinal Twin Buoy out of Position

Mariners are also advised that the seabed obstruction (5.0m below ACD), that the Twin Buoys mark, is now un-marked.

Mariners are requested to navigate with caution in Lowestoft Approaches. Updates of the buoy position, particularly if different to the above, should be passed to Lowestoft Port Control whenever possible.

Work is in hand to arrange for the buoy to be recovered and reinstated in position ASAP.
